FIRE TEST REPORT EUI-23-B-000463

According to BS EN 1363-1:2020 and BS EN 1365-2:2014

Test	EUI-23-B-000463
Performed on	27 th February 2024
Regarding	Ecolit Loadbearing 60-Minute Floor. Overall dimension: 2980 x 4280 x 335mm (w x L x th) Loading: 2.5 kN/m ²
Sponsor	ECOLIT LISMULLEN, GARLOW CROSS C15 R273 NAVAN IRELAND

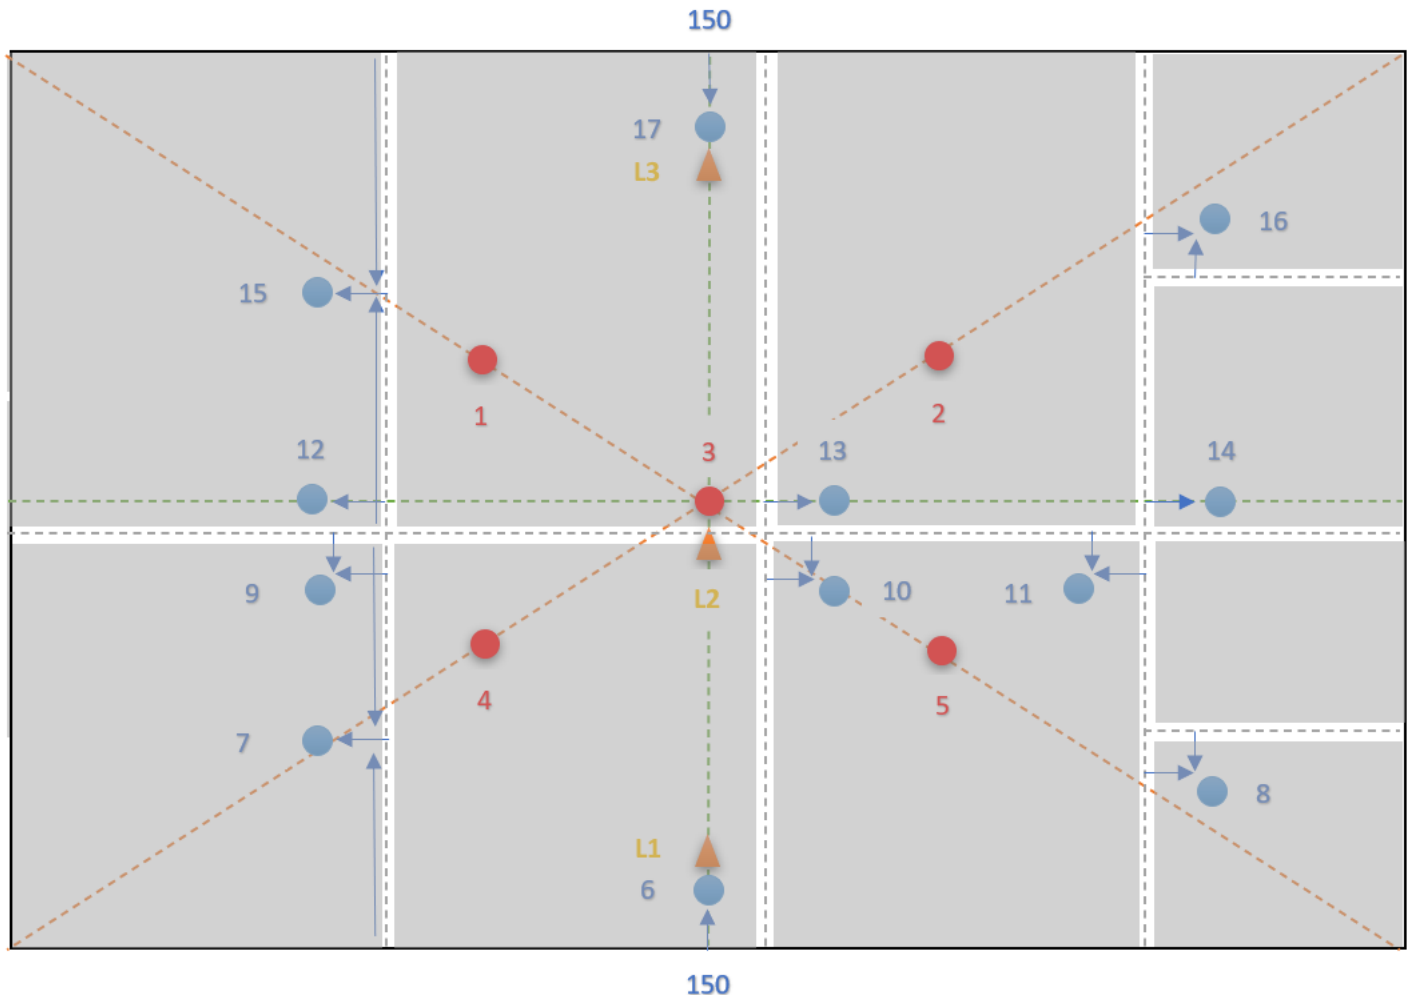
Figure 1 – Plot of the instrumentation installed on the unexposed side of the sample.

Thermocouples 1 to 5 to be installed no less than 50mm from hotspots(joints, screws, etc).

Remaining thermocouples to be installed no less than 20mm from hotspots.

- Thermocouples for average Temperature rise (1 – 5).
- Thermocouples for maximum Temperature rise (6 – 17).
- ▲ LVDTs (L1 – L3).

The temperatures on the unexposed side of the specimen were measured by 17 thermocouples according to the requirements of the standard BS EN 1363-1:2020 and located according to the standard BS EN 1365-2:2014.

See Figure 1, Appendix B for the plot of the instrumentation, and Charts 5 to 6, Appendix C for the measurements recorded during the test.

Location	Markings	Appendix
On the centre of the quadrant	1, 2, 4, 5	B
On the geometric centre of the specimen	3	
Adjacent to intersecting joints	7, 8, 9, 10, 11, 15, 16	
At mid-span, adjacent to a joint	12, 13, 14	
At mid-span, 150 mm from the edge of the sample	6, 17

In conformity with the requirements of the standard BS EN 1363-1:2020, the deflection of the sample was measured using calibrated wire type displacement gauges and recorded via a data acquisition system, near the edge and on the centre of the sample. See Figure 1 Appendix B for the plot of the instrumentation and Charts 10 and 11, Appendix C for the measurements recorded during the test.

Location	Markings	Appendix
Mid-span – 50 mm from the edge of the sample ("Logger box side")	1	B
Centre of the sample	2	
Mid-span – 50 mm from the edge of the sample ("Wall side")	3

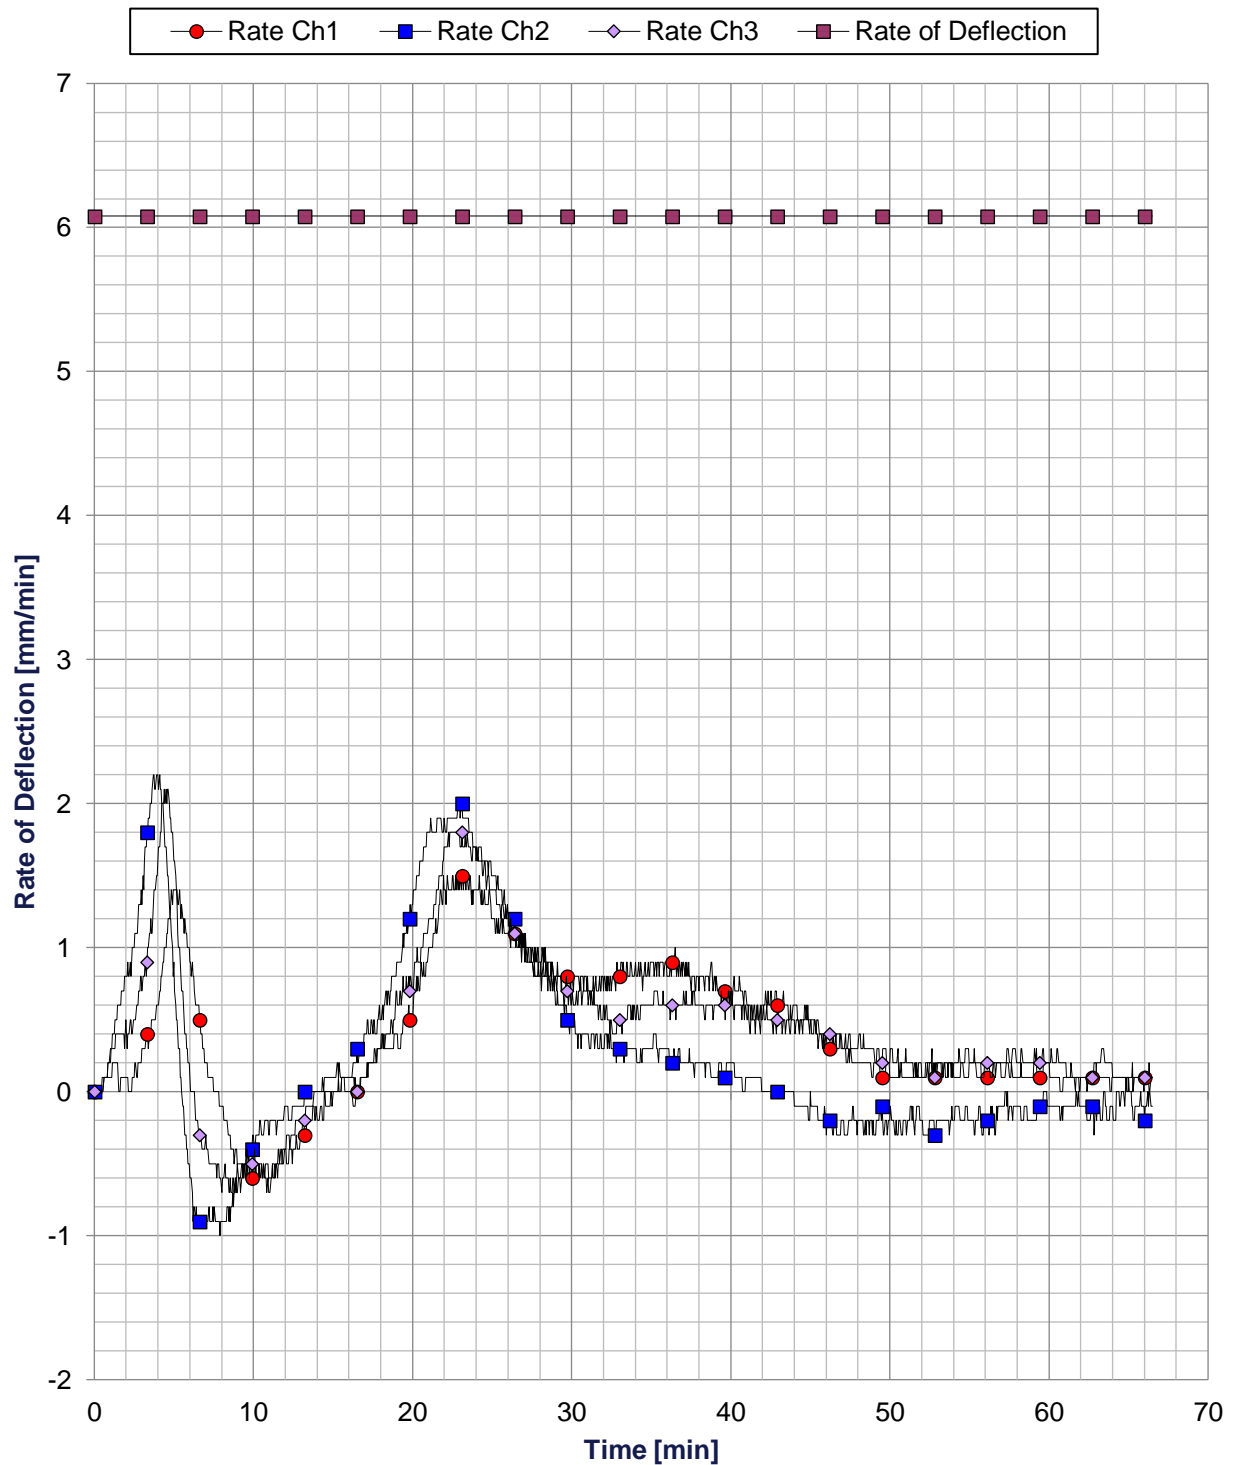
Chart 8 – Rate of vertical deflection recorded during the test.

Duration: **SIXTY-SIX MINUTES (66 Min)**
Cause of limitation: No Failure - End of test at the request of the sponsor.

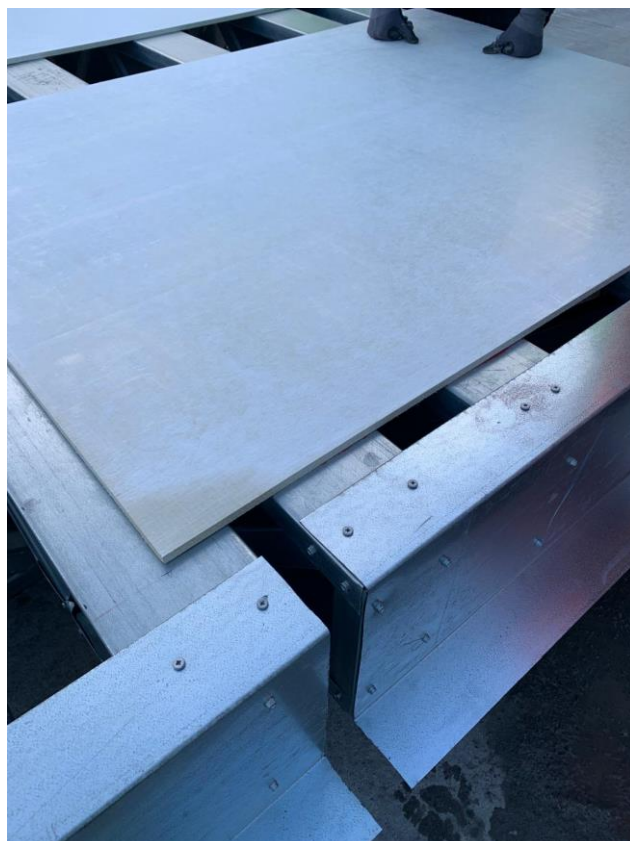
Photograph 2 – Sample during the construction – Ceiling Panels fitting in steel frame.

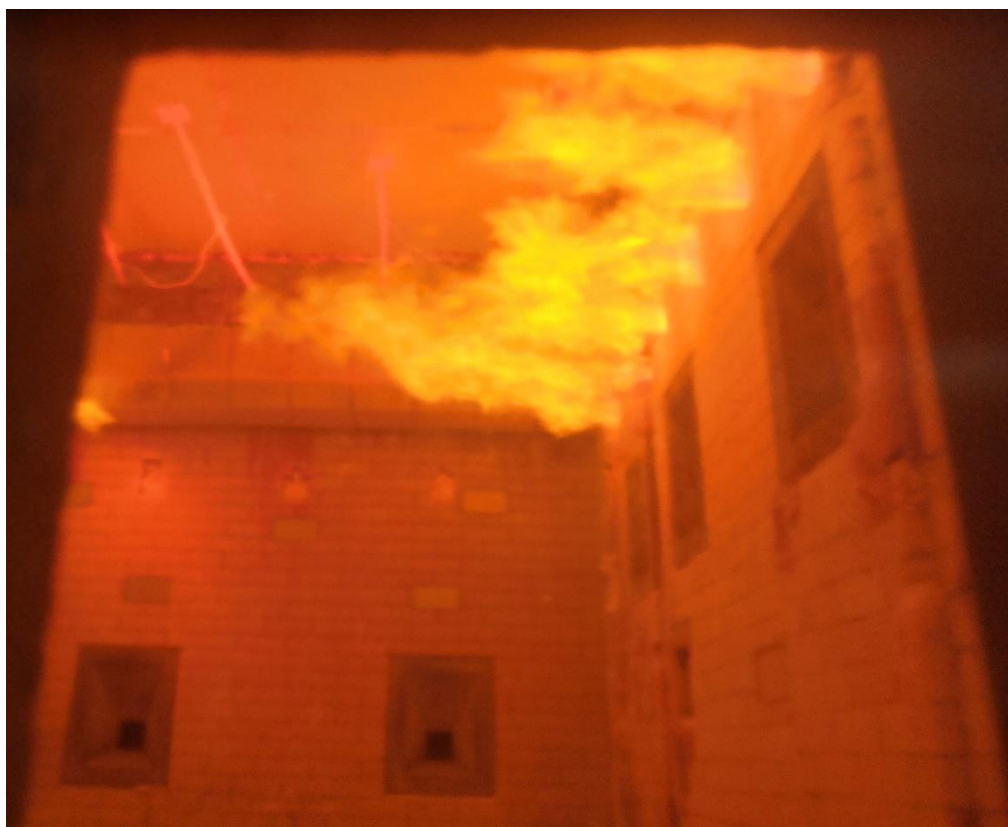
Photograph 12 - Detail of the exposed side of the sample during the test. Photograph taken during minute 35.

Time (min)	Specimen	Observations
00	NES/ES	Start of the test.
3	NES	A small amount of smoke was released from the long side edges.
9	NES	More smoke was released from the long side edges.
13	ES	NSC.
15	NES	Smoke was released from the perimeters.
30	ES	NSC.
35	ES	The mid portion joints turned black.
42	ES	NSC
45	NES	More smoke was released from the sides of the specimen.
57	ES	Flames on the long board joints.
60	NES	NSC
66	ES/NES	End of test at the request of the sponsor.

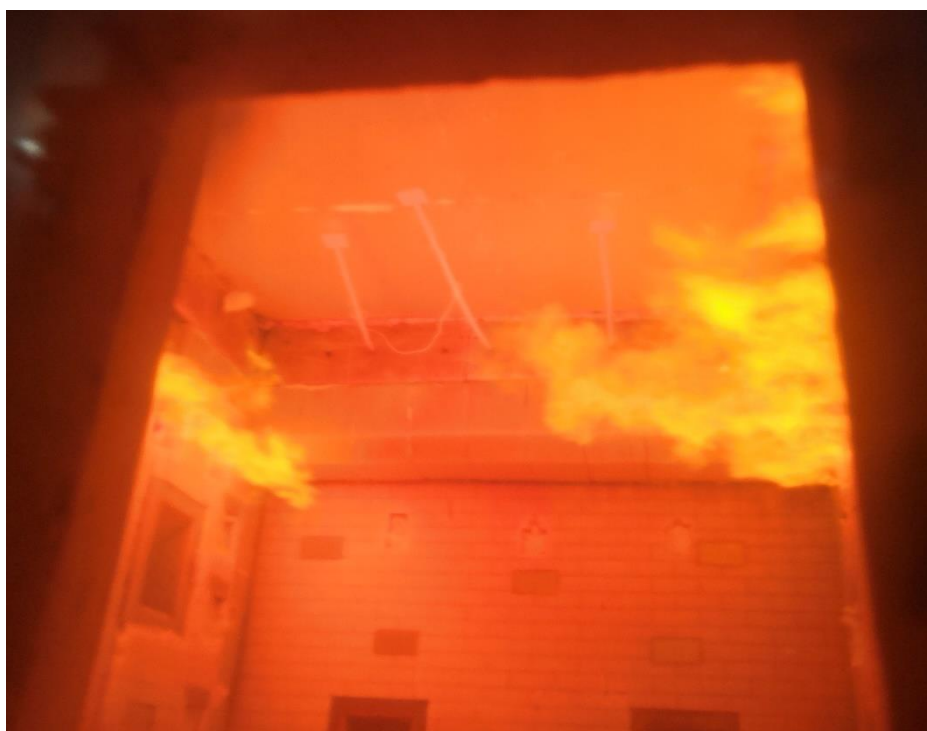
Photograph 15 - Detail of the exposed side of the sample during the test. Photograph taken during minute 57.

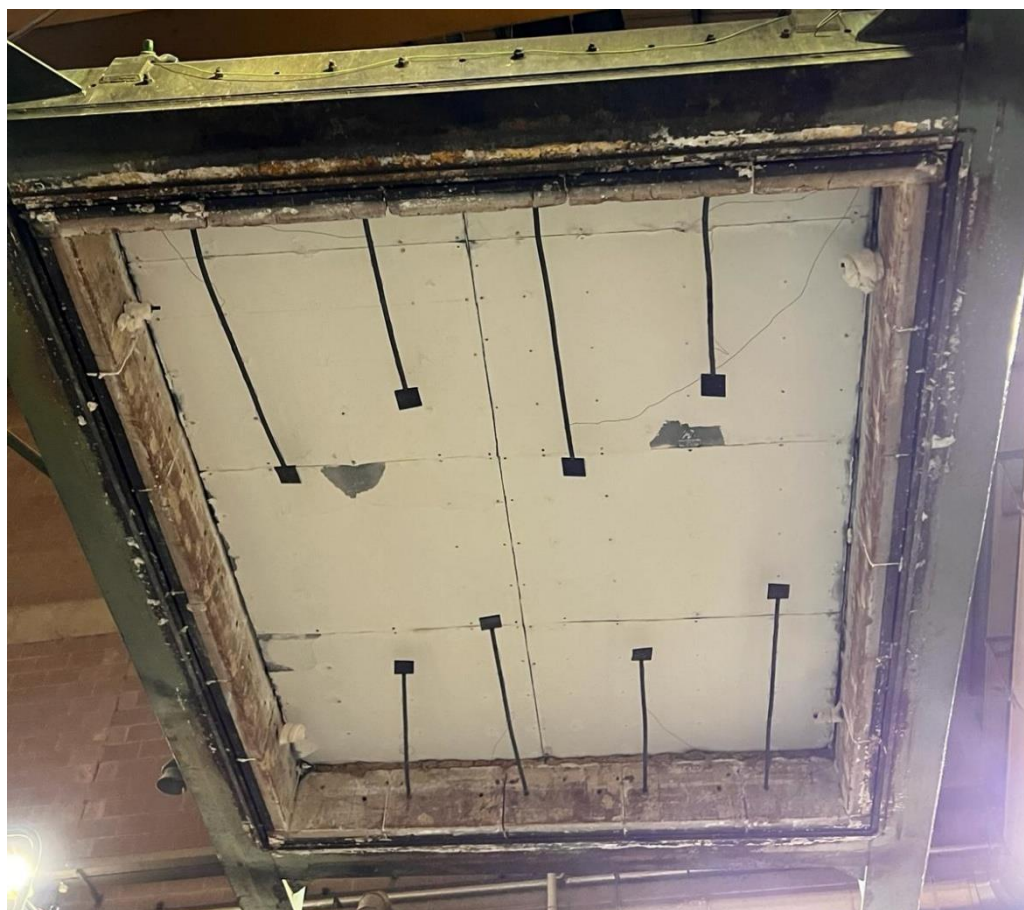
Photograph 18 - Detail of the exposed side of the sample after the test.

The centre of the specimen deflected towards to the furnace.

See Photographs 18 and 19, Appendix D.

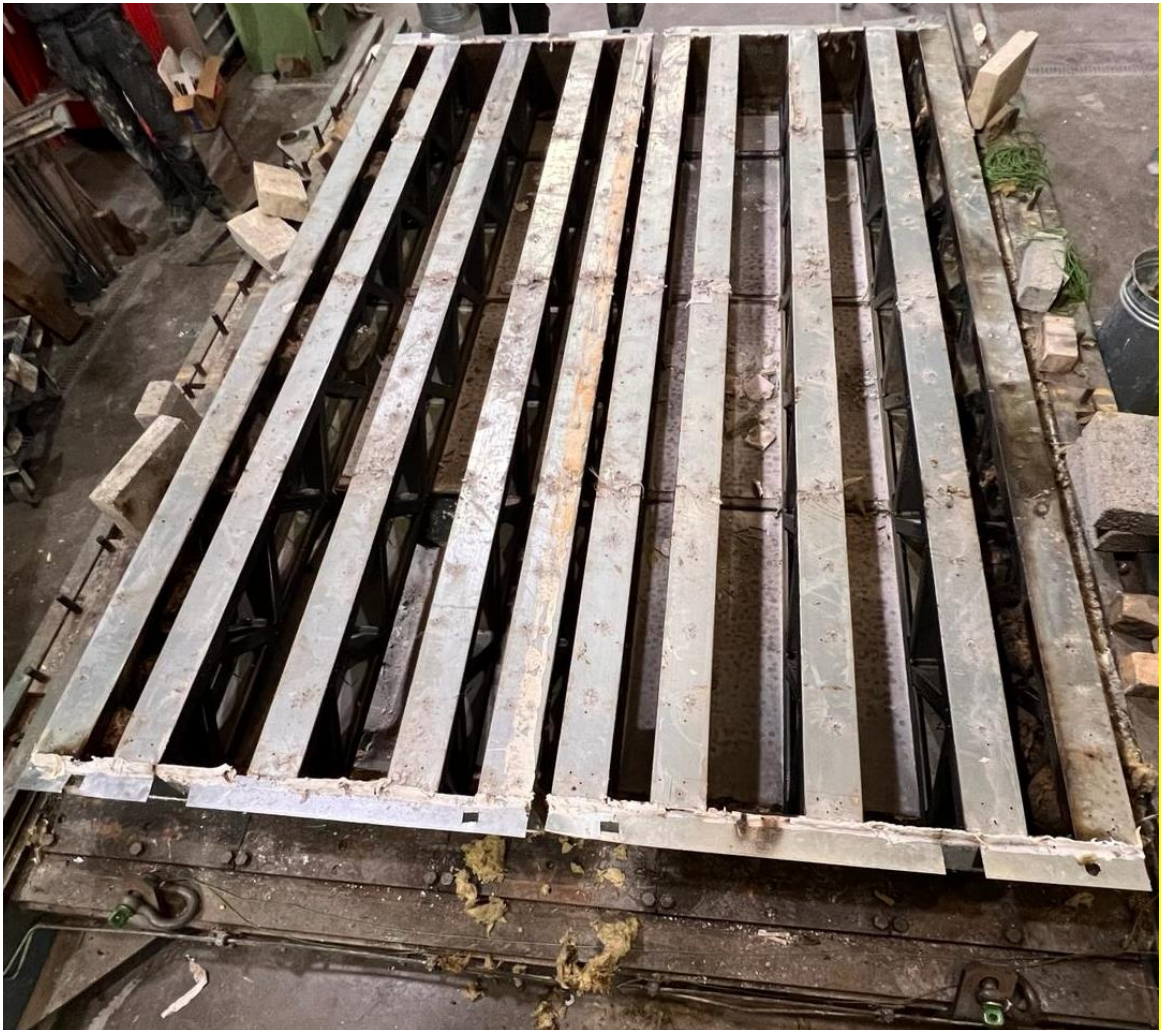
Photograph 19 - Overall view of the unexposed side of the sample during dismantling.
